LAKE COUNTY, ILLINOIS

2011 DRUCE LAKE SUMMARY REPORT

PREPARED BY THE ENVIRONMENTAL SERVICES
 LAKE COUNTY HEALTH DEPARTMENT
 POPULATION HEALTH ENVIRONMENTAL SERVICES

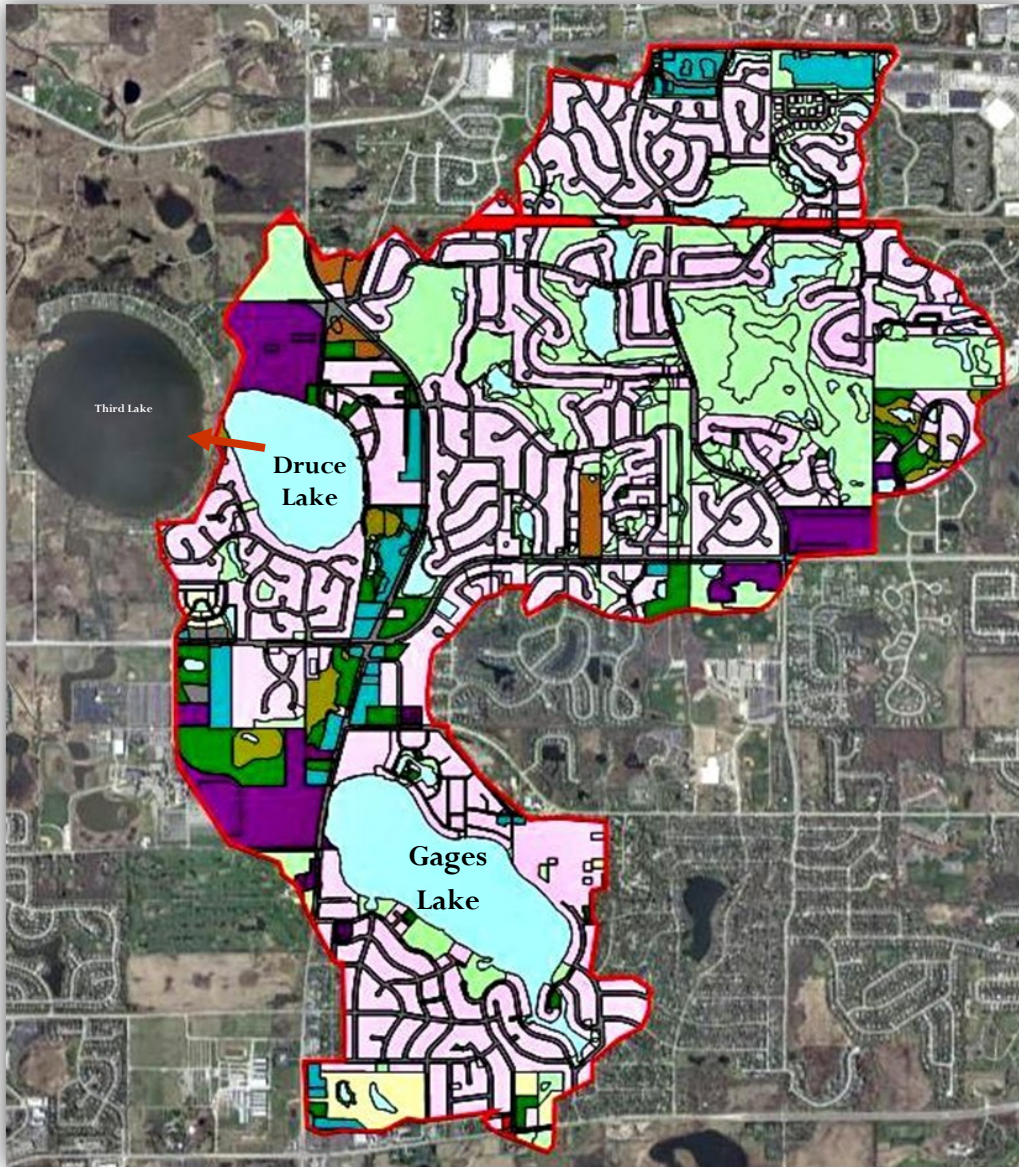
The two major sources of runoff for Druce Lake were transportation (36.6%) and single family (34.2%). The impervious surfaces (parking lots, roads, buildings, compacted soil) do not allow rain to infiltrate into the ground. Land management practices of the large amount of residential area in the water shed impacts the lake. The developed area in the Druce Lake watershed is 62.9%. Controlling water that runs from the land's surface into the lake is important for drainage lakes.

2011 Land use in the Druce Lake watershed	
	Water
	Disturbed Land
	Transportation
	Agricultural
	Government and Institutional
	Wetlands
	Utility and Waste Facilities
	Single Family
	Office
	Retail/Commercial
	Industrial
	Multi Family
	Forest and Grassland
	Public and Private Open Space

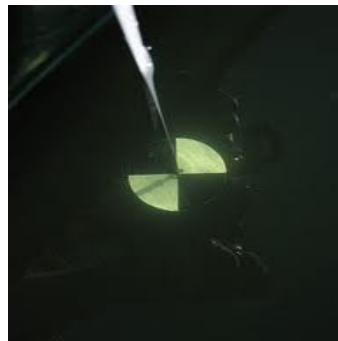
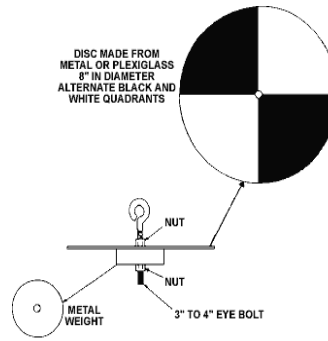
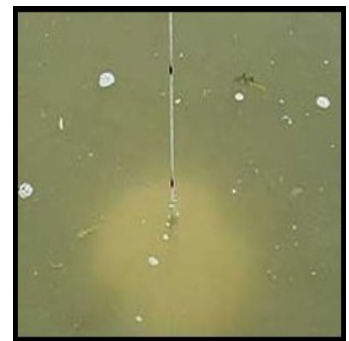
SECCHI DISK AVERAGES
FROM VLMP AND LCHD
RECORDS FOR DRUCE LAKE
1986—2011.

■ Average Depth (feet) VLMP
■ Average Depth (feet) LCHD

in the VLMP program has provided Druce Lake with annual baseline data that can be used to determine long term water quality trends and support current lake management decision making. The average VLMP Secchi disk depth from 2001 was 7.42 feet. Annual VLMP readings have varied

from 4.40 feet in 1986 to 11.22 feet in 2009. The volunteers on Druce Lake have provided data that is vital for the continued monitoring and management of this lake. The LCHD-ES would like to thank them for their efforts and recommend continued involvement in the future.

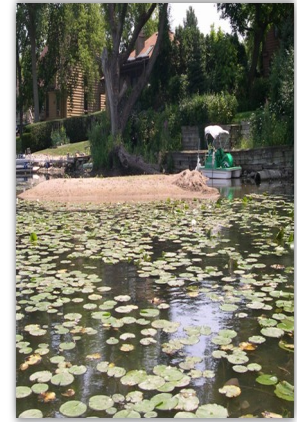
Sediments entering Druce Lake from an inlet

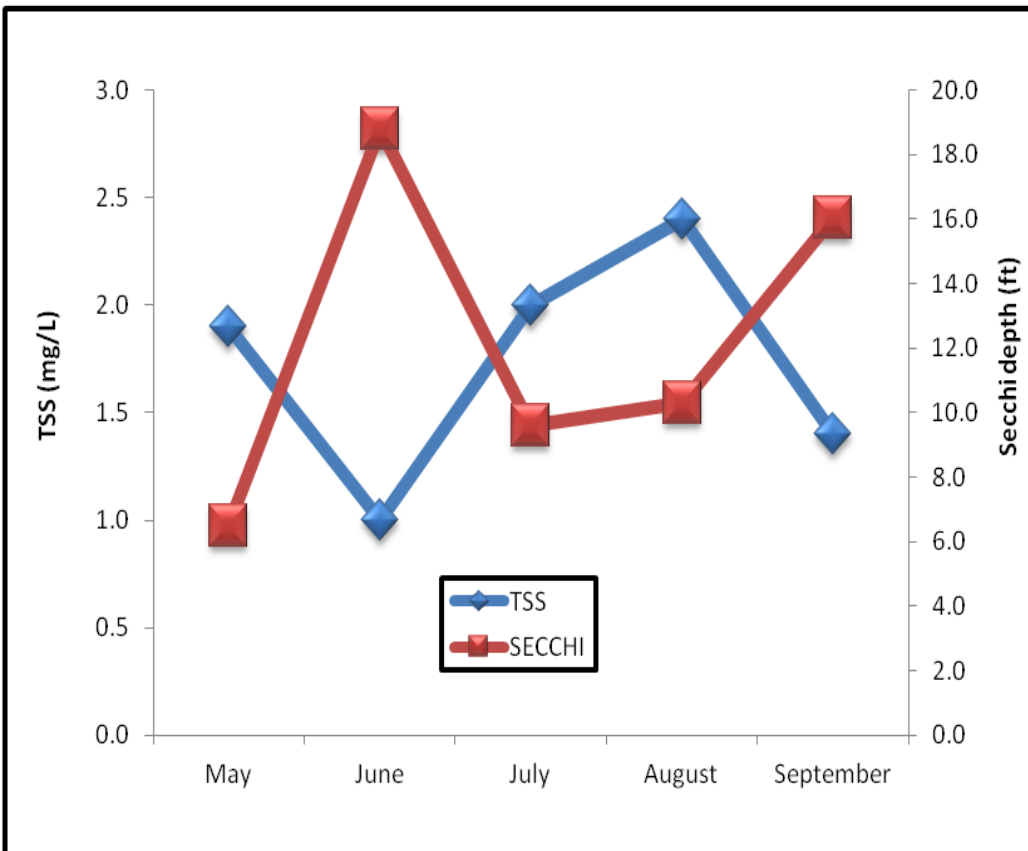
The shallowest Secchi recorded depth in 2011 occurred in May (6.50 feet) and the deepest was in June (18.80 feet) corresponding with the lowest 2011 TSS concentration (1.0 mg/L). This may have been affected by wind and rainstorms causing erosion and runoff from streams causing a higher concentrations of suspended particles flowing into the lake.

In June, the deepest Secchi reading for the season, was recorded. Clarity gradually decreased as the water temperature increased in July and August.

DATE (2011)	TSS (mg/L)	SECCHI (ft)
May	1.9	6.50
June	1.0	18.80
July	2.0	9.60
August	2.4	10.30
September	1.4	16.05

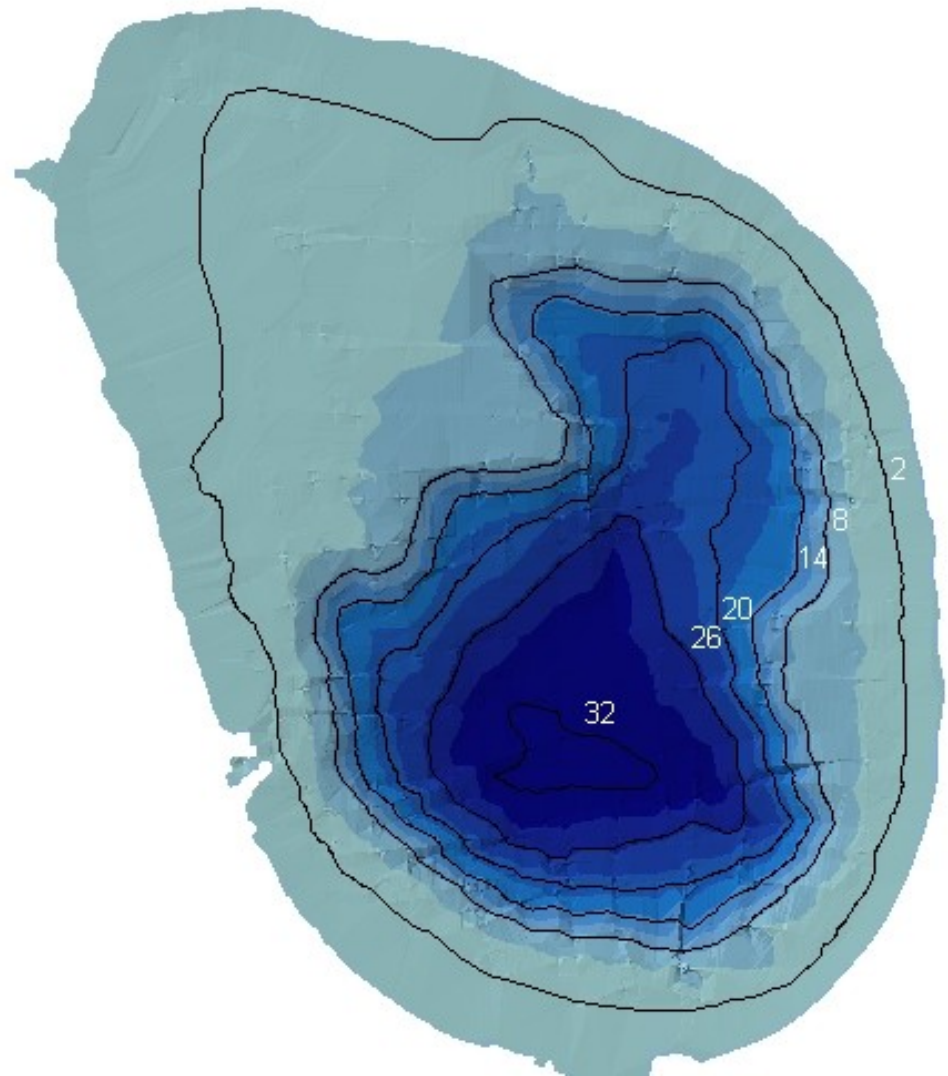
data to replace the bathymetric map created by the LCHD-ES in 1994. The field data was collected using Biosonics equipment along with a Trimble GPS unit with sub-foot accuracy. Once collected, the data was analyzed and imported into ArcGis for further analysis. In ArcGis, the contours were drawn and the volume was calculated.

Survey Data Collected November 2006

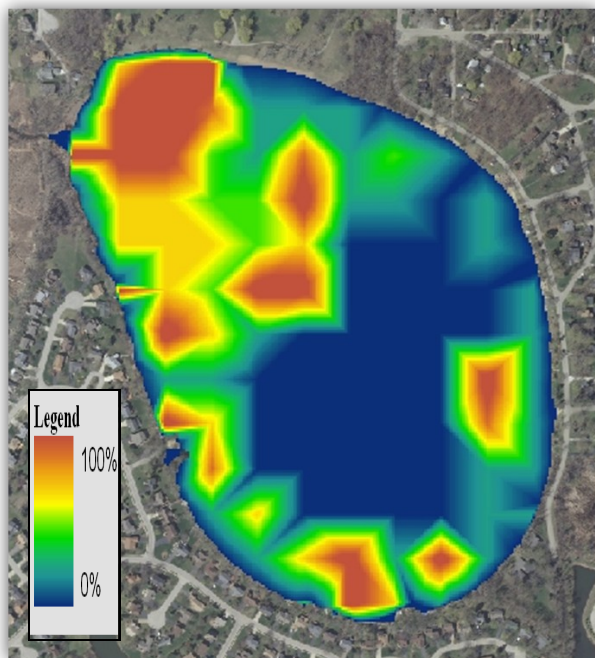
DISTRIBUTION OF RAKE DENSITY ACROSS ALL SAMPLES SITES IN 2011

Rake Density (Coverage)	# of Sites	%
No plants	10	10.1
>0 to 10%	26	26.3
>10 to 40%	6	6.1
>40 to 60%	14	14.1
>60 to 90%	4	4.0
>90%	17	17.2
Total Sites with Plants	67	67.7
Total # of Sites	99	100.0

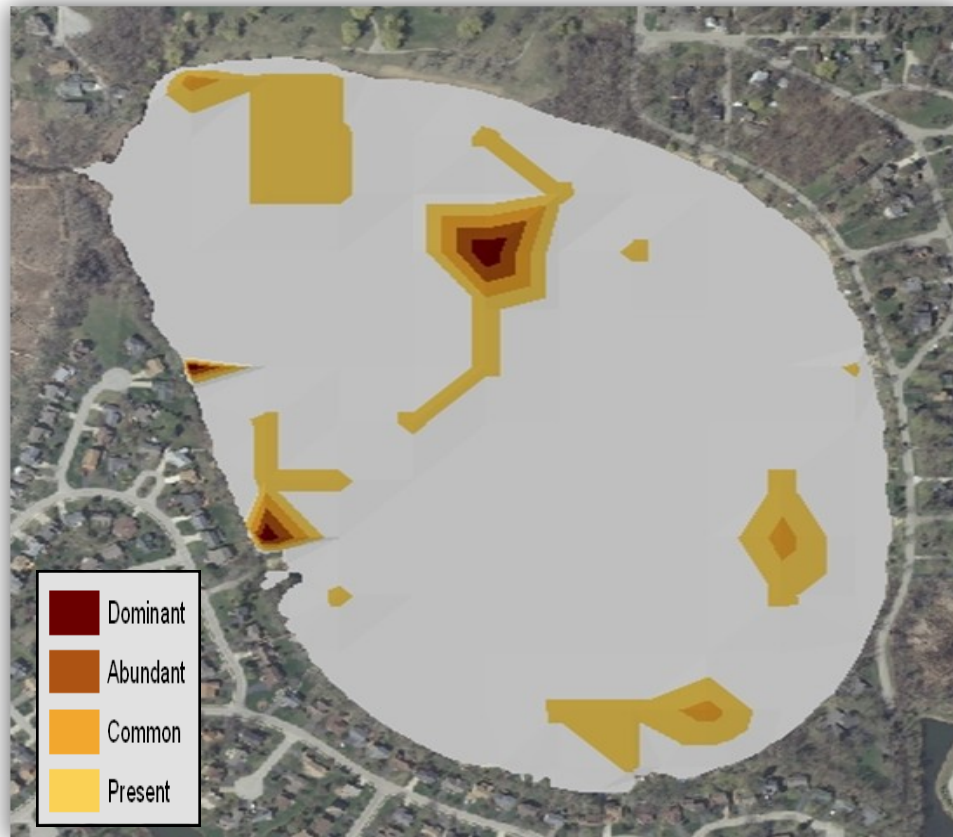
has invaded nearly every US state and at least three Canadian Provinces. Eurasian watermilfoil was commonly found at a majority of the sampling sites in 2001 and in July 2011 it was observed at 29.3% of the sampling sites in Druce Lake. This exotic plant species invaded Druce Lake in the early 1990's and by 1994 had formed a ring around the eastern and southern half of the lake. Plant surveys in 1995 showed a decrease in EWM density and in 2001 the

EWM at the boat launch and the southern shore exhibited damage characteristic of milfoil weevil activity. There has been success in controlling EWM density by milfoil weevil in Druce Lake. Since weevil population correlates with the EWM density, a cyclical resurgence of EWM infestation occurs. Treatment with chemicals or hand pulling with a rake in areas that have high density of the invasive plant maybe necessary to control EWM.

ERASIAN WATERMILFOIL DENSITY AT 29 SITES ON DRUCE LAKE IN JULY, 2011, MAXIMUM DEPTH THAT PLANTS WERE FOUND WAS 10.1 FEET.

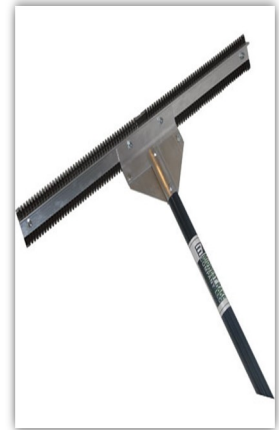
Aquatic Rake with Blade

tion and fish. There are different types of rakes. First is a bladed rake that can be used to cut the stems of plants. Secondly, a throw able double sided rake that can be used to pull plants from deeper water or further distances and lastly a long handled rake for working the shoreline and the boat dock area. Its important to remove the entire plant including the roots to prevent regeneration.

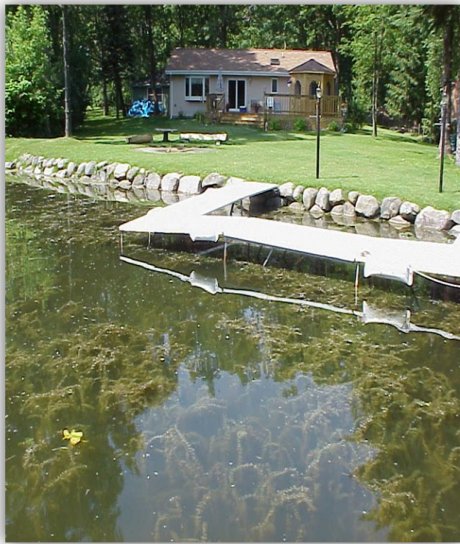
Before EWM Treatment

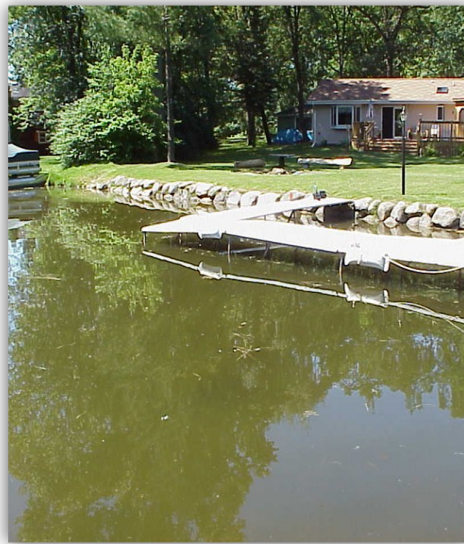
After EWM Treatment

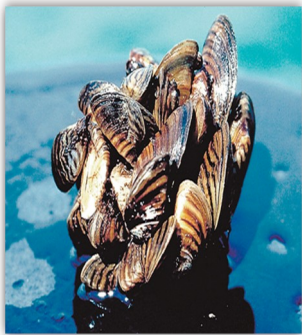
Zebra mussel form a colony called "Drusses"

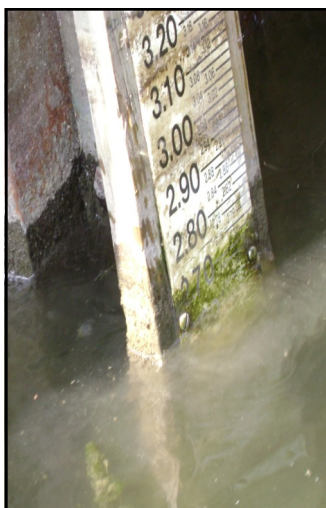
to rainfall events and can aid in future decisions regarding lake level. Staff gauge is a great tool for measuring water level in lakes, rivers, reservoirs. The data collected can be compiled to help understand the natural fluctuations of the lake. Large fluctuations in lake level can lead to shoreline erosion.

PERMANENT STAFF GAGE AT THIRD LAKE

2011	Level (in)	Seasonal Change	Monthly change (in)
May	28		
June	32	-4	-4
July	35	-7	-3
August	32	-4	3
September	28.75	-0.75	3.25

Druce Lake has a large watershed that covers 2500 acres, which helps replenish water lost through evaporation during the summer. It is recommended that in the future, staff gauge readings be taken weekly or bi-weekly if possible. This will give lake managers a much better idea of lake level fluctuations relative

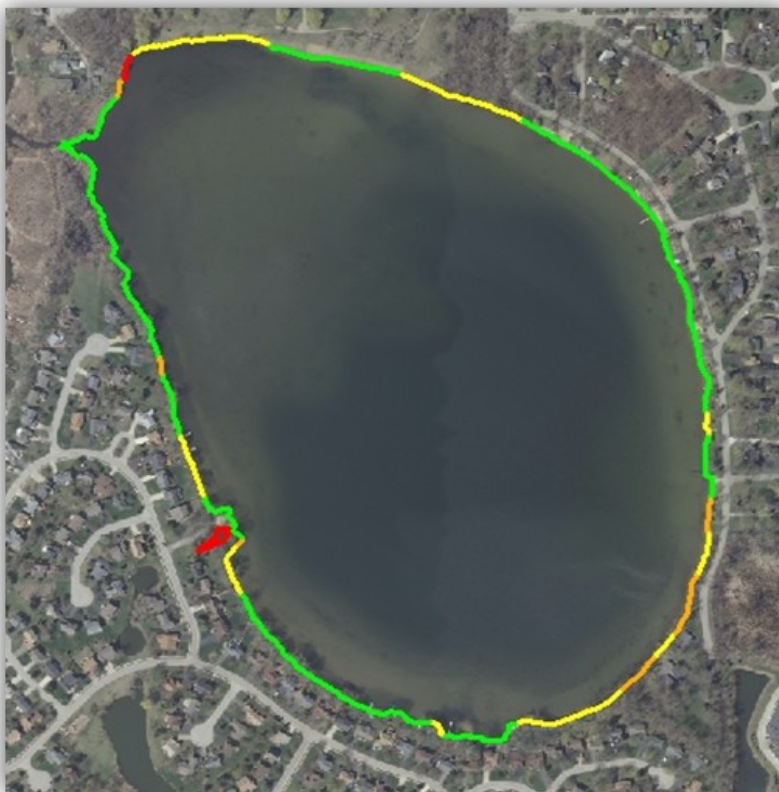
DRUCE LAKE INLET LINED WITH ROCKS AND VEGETATION TO PREVENT EROSION

before newly planted seed and vegetation has a chance to grow. Eroded materials cause turbidity, sedimentation, nutrients, and pollutants to enter a lake. Shore line buffer zone planted with native vegetation not only reduces runoff by increasing water infiltration into the ground, it also offers food and habitat for wildlife. Less runoff means less nutrients and other pollutants entering the lakes and streams. Excess nutrients are the primary cause of algal blooms and increased aquatic plant growth. Once in the lake, sediments, nutrients and pollutants are harder and more expensive to remove.
